# RIBA Stage 1

## St Ives Huer's Hut

Sustainable Future Reuse  
Feasibility Project

Lavigne  
Lonsdale

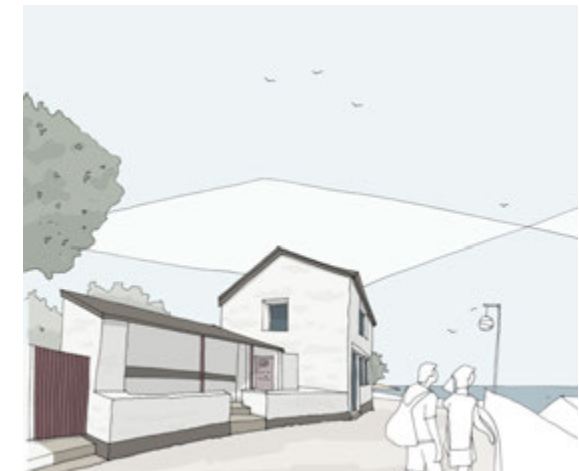
Opt 1

Stage 1 developed and tested three options, each sharing the same essential conservation repair and differing only in how far it takes the building toward optimum viable use: Option 1 stabilises and protects the Hut without bringing it into regular use, Option 2 repairs and adapts it to deliver the artist and crafter's residence with public access to the ground floor for the first time, and Option 3 adds a modest extension within the south shelter for exhibition or community use. Each option was assessed against the same criteria: conservation impact, viability and deliverability, accessibility, sustainability, cost and suitability for the NLHF capital grant application. The comparison is summarised in Section 4.5.

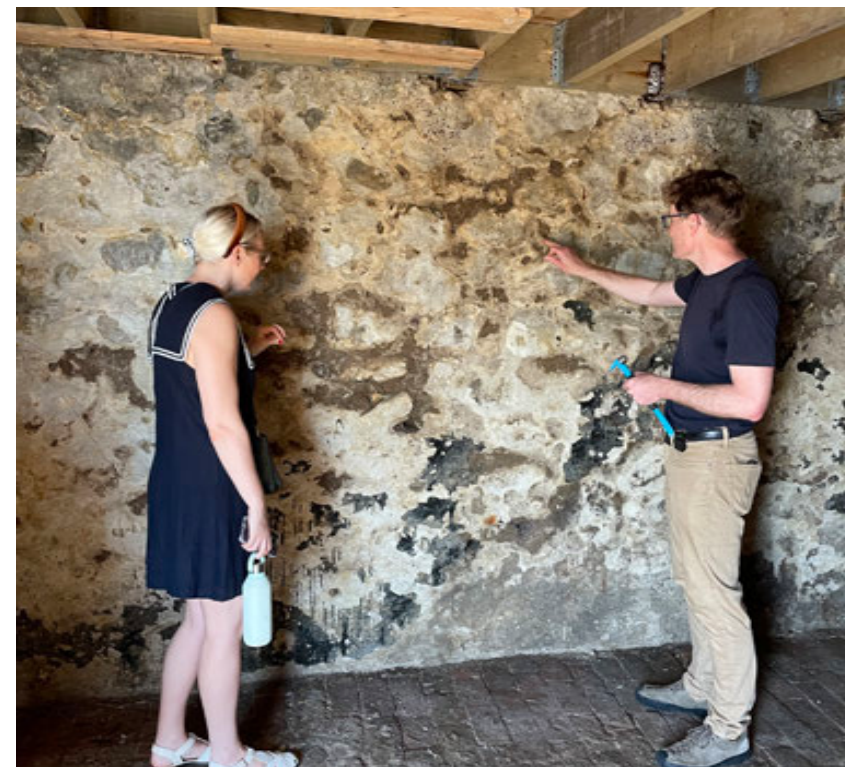
Constructed from local stone and laid in an earth mortar with a very weak binder. The interlocking arrangement of the stones is fundamental to the wall's stability. The wall faces have been pointed in lime mortar and subsequently rendered and limewashed. Samples have been submitted for analysis the findings of which will inform consolidation and repair methods. The lime-based coverings are essential for maintaining the walls' health and stability and would historically have been renewed seasonally as part of routine building maintenance.

Behind the west (rear) wall, the rock may have been dressed back to create a shelf upon which the building was constructed. The earliest available map indicates that a path once passed behind the building, which would be consistent with historic access on foot. The rear wall appears to be the most intact and

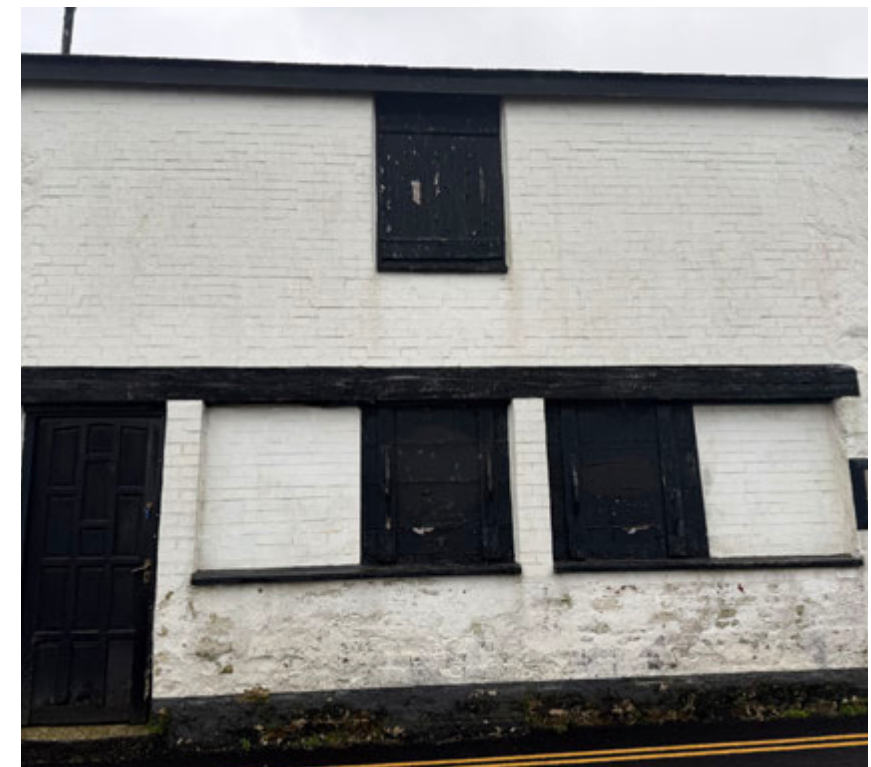
#### EAST GABLE

This has been rebuilt on at least two occasions during the building's life. The presence of imperial bricks dating from approximately 1890–1915 suggests reconstruction as part of a significant renovation campaign (likely Hain 1904). It was rebuilt again around 1976 following a partial collapse. This later intervention introduced much of the brick, concrete and cement fabric currently present.

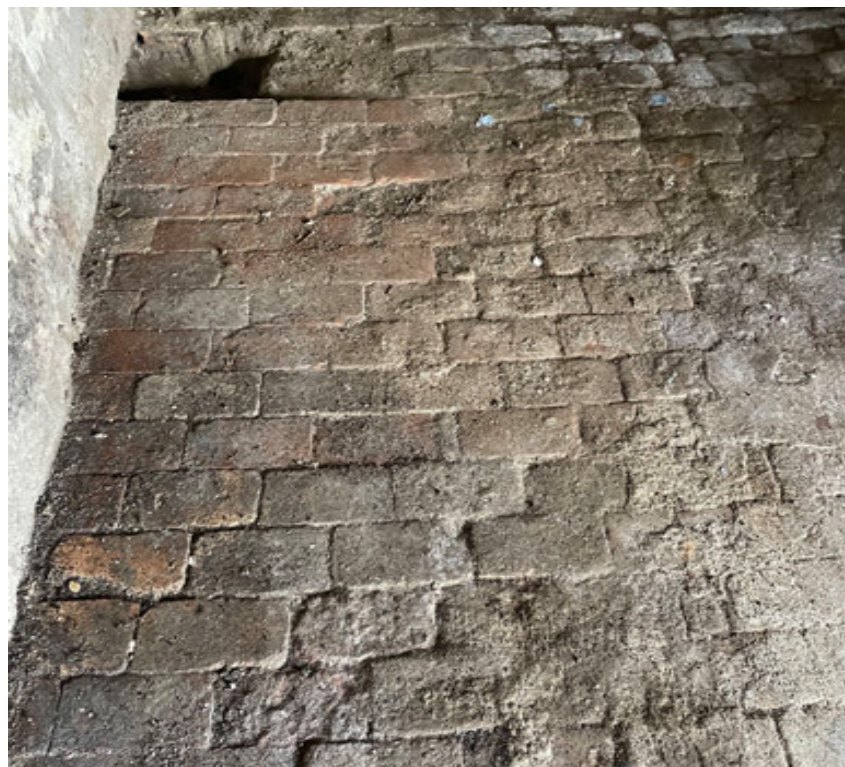
#### FLOOR

Constructed of Victorian brick and not original to the building, although likely installed as part of consolidation works of 1904. The floor is bedded on a sand-rich mixture with little evidence of a binder. The underlying rock appears likely to have been dressed back to create a relatively level surface.

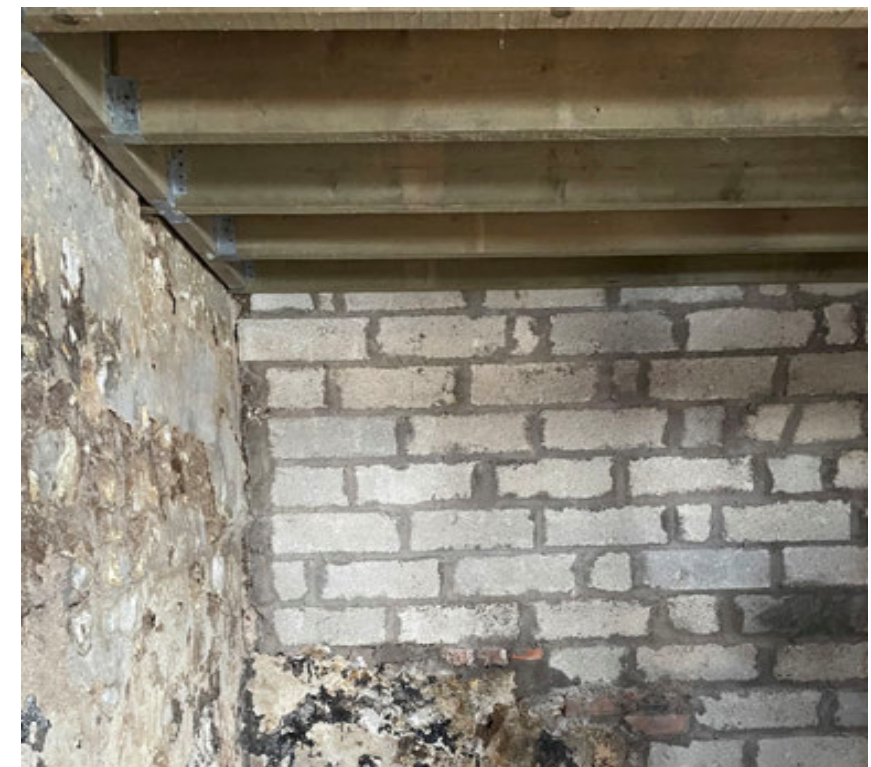
#### INTERNAL FIRST FLOOR

Constructed in softwood and supported using galvanised joist hangers. The floor is lined with tongue-and-groove boarding. Neither the detailing nor the materials are historic. A replacement floor should reflect the traditional detailing but also be of suitable materials.

The first floor joists are modern, in poor condition and partially replaced, and should be renewed. New timbers will be specified for resistance to moisture and rot and detailed to suit the nature of the walls, while the historic brick paviour floor at ground level is retained and relaid where lifted.

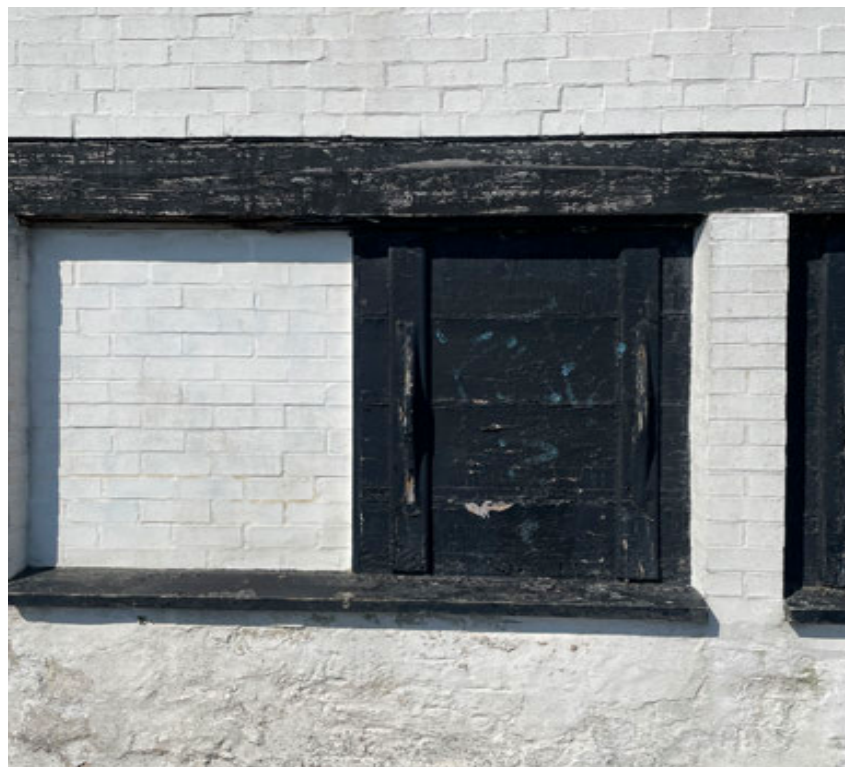
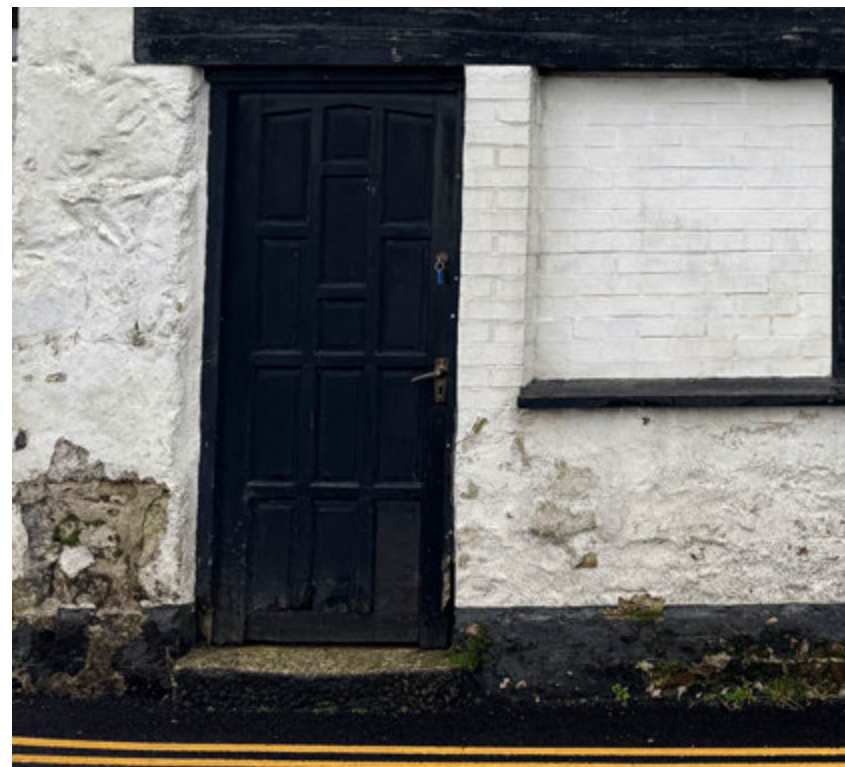
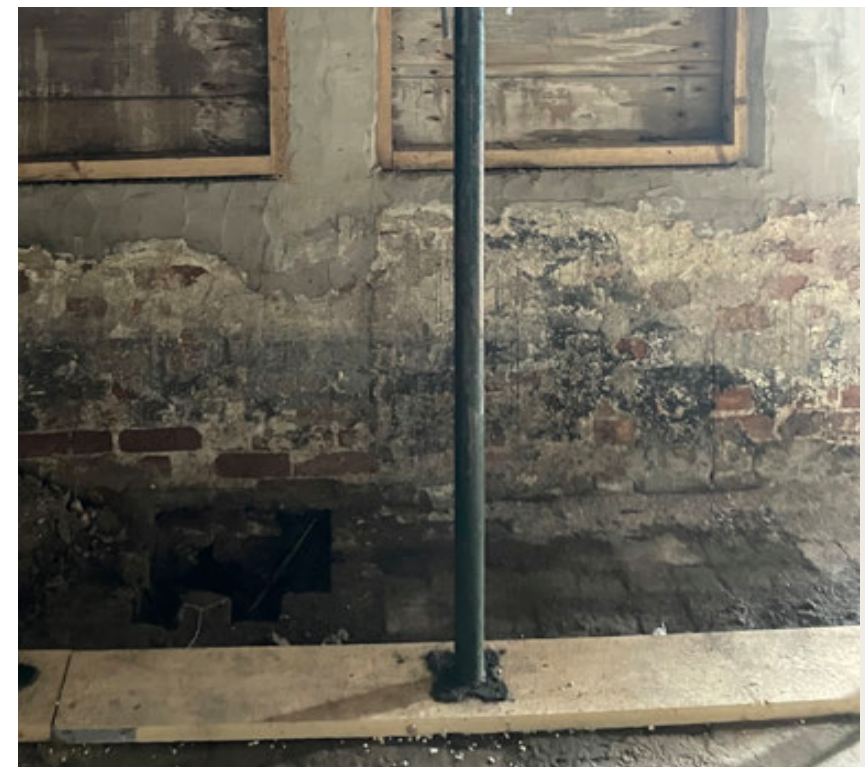
#### DEFECTS

Inadequate ventilation has resulted in a damp and stagnant internal environment conducive to mould growth and the development of dry rot. Moisture saturation within the walls has led to advanced wet rot in many timber elements.

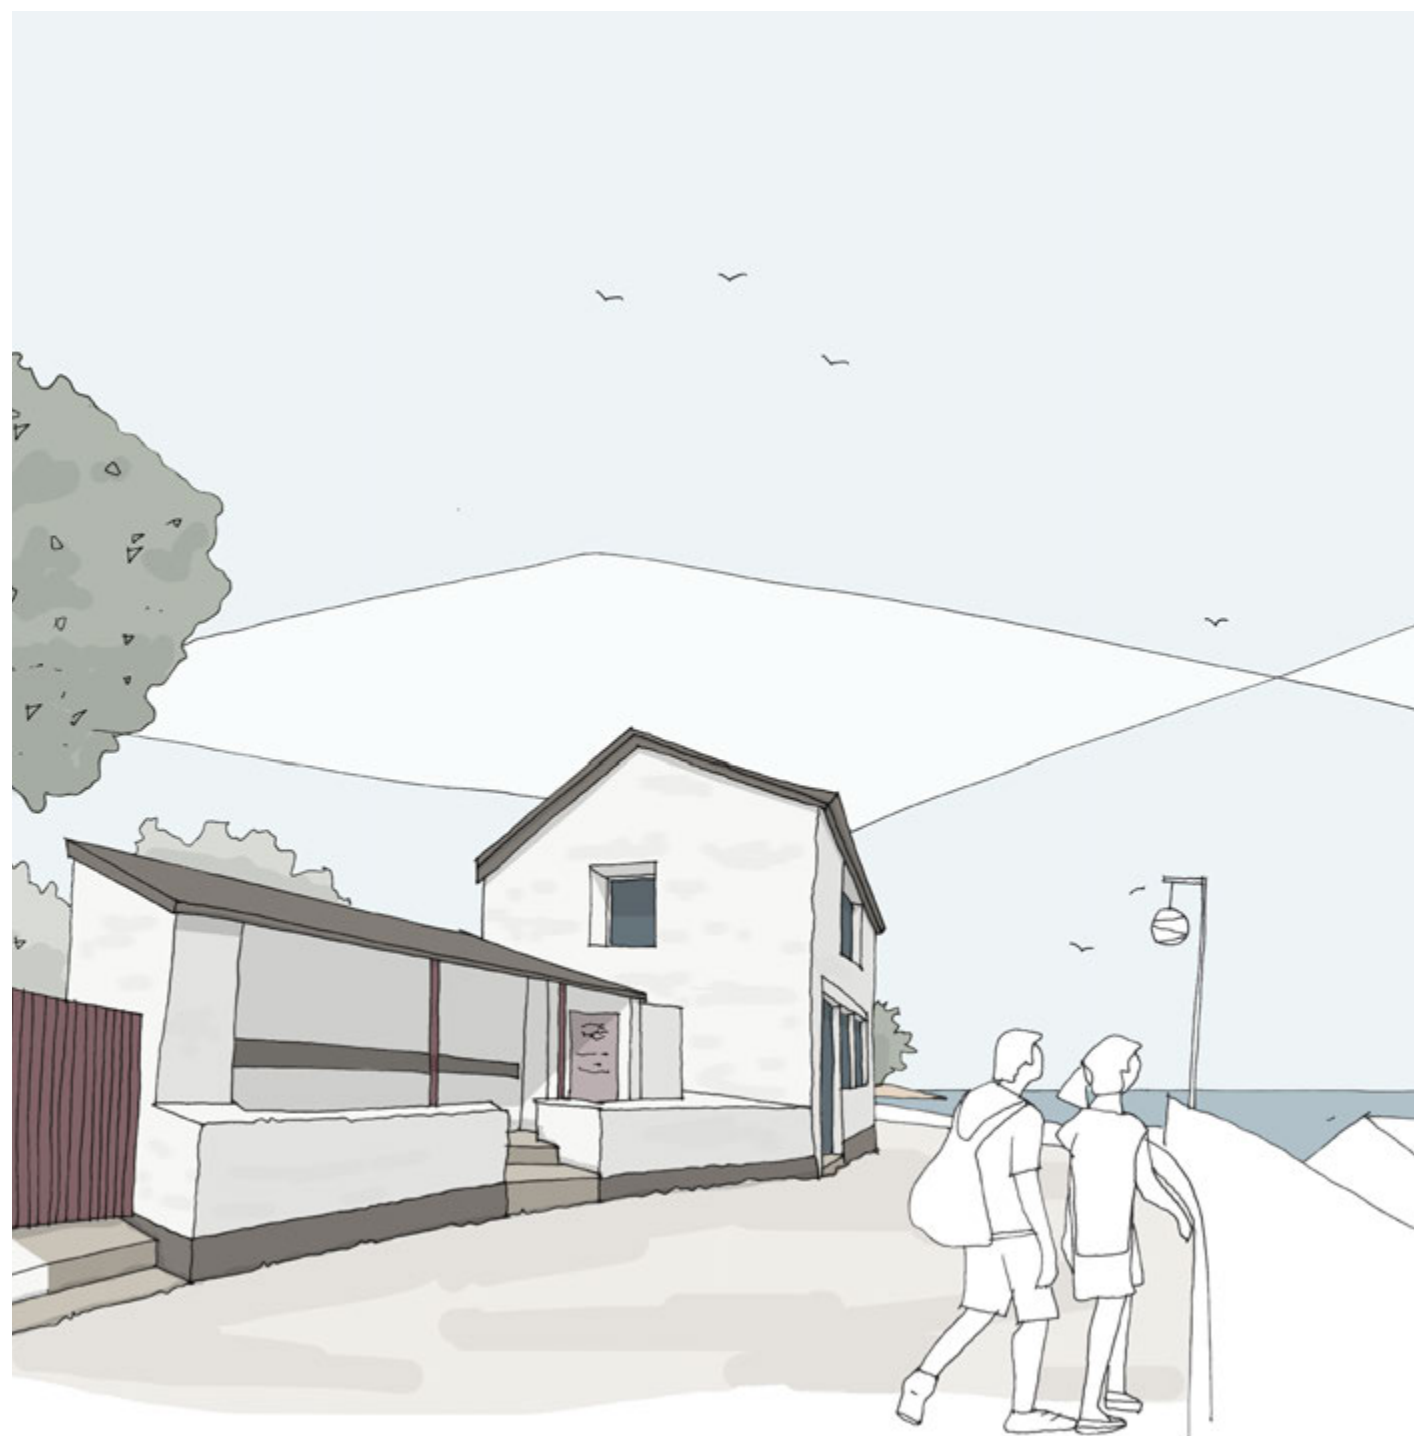
Routine observation and conservation aware maintenance to prevent immediate deterioration, including monitoring the roof, keeping rainwater goods clear and keeping access open.

Heritage values remain guarded and the risk of further decay is reduced. The building is made safe and its significance protected, but the opportunity to bring it back into public life is not taken.

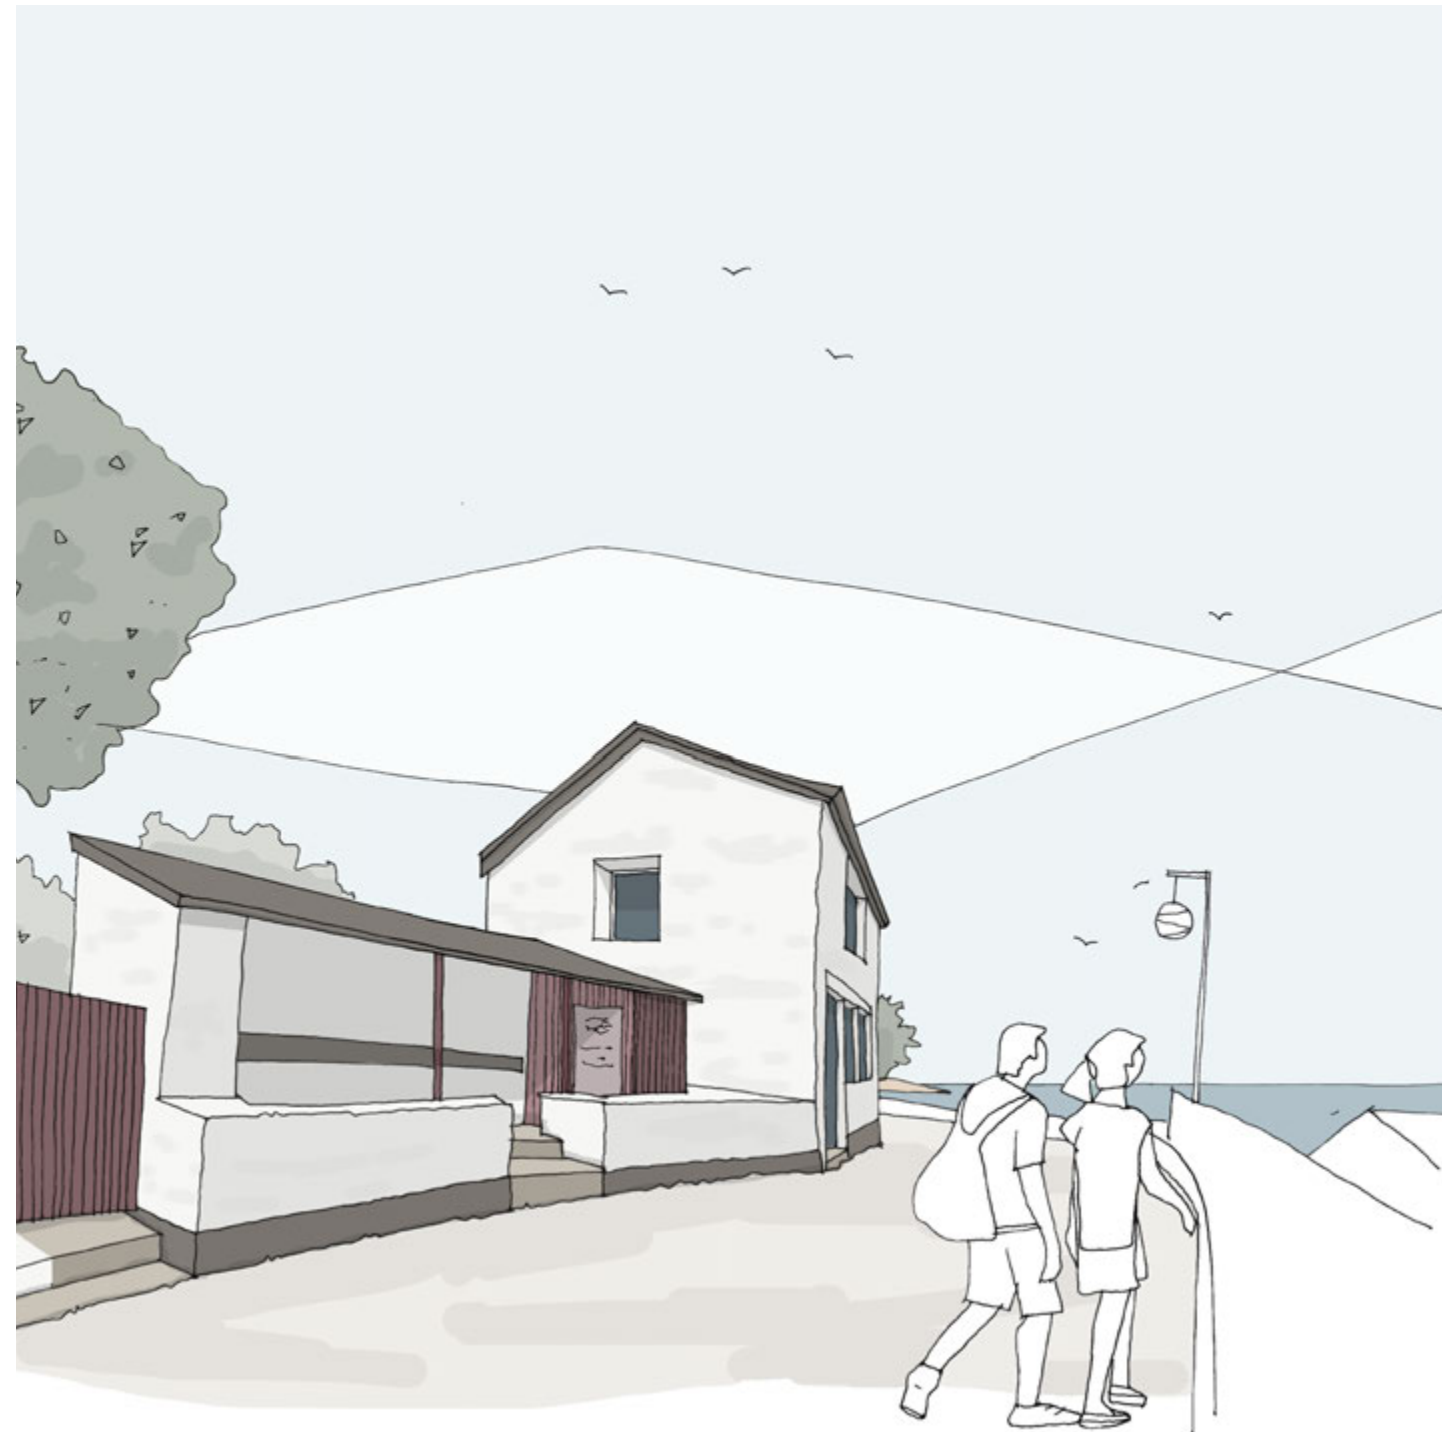
This option improves longevity, conserves heritage values and enables active reuse with light public access. It takes the change of use furthest within the existing fabric and footprint, keeping heritage impact proportionate.

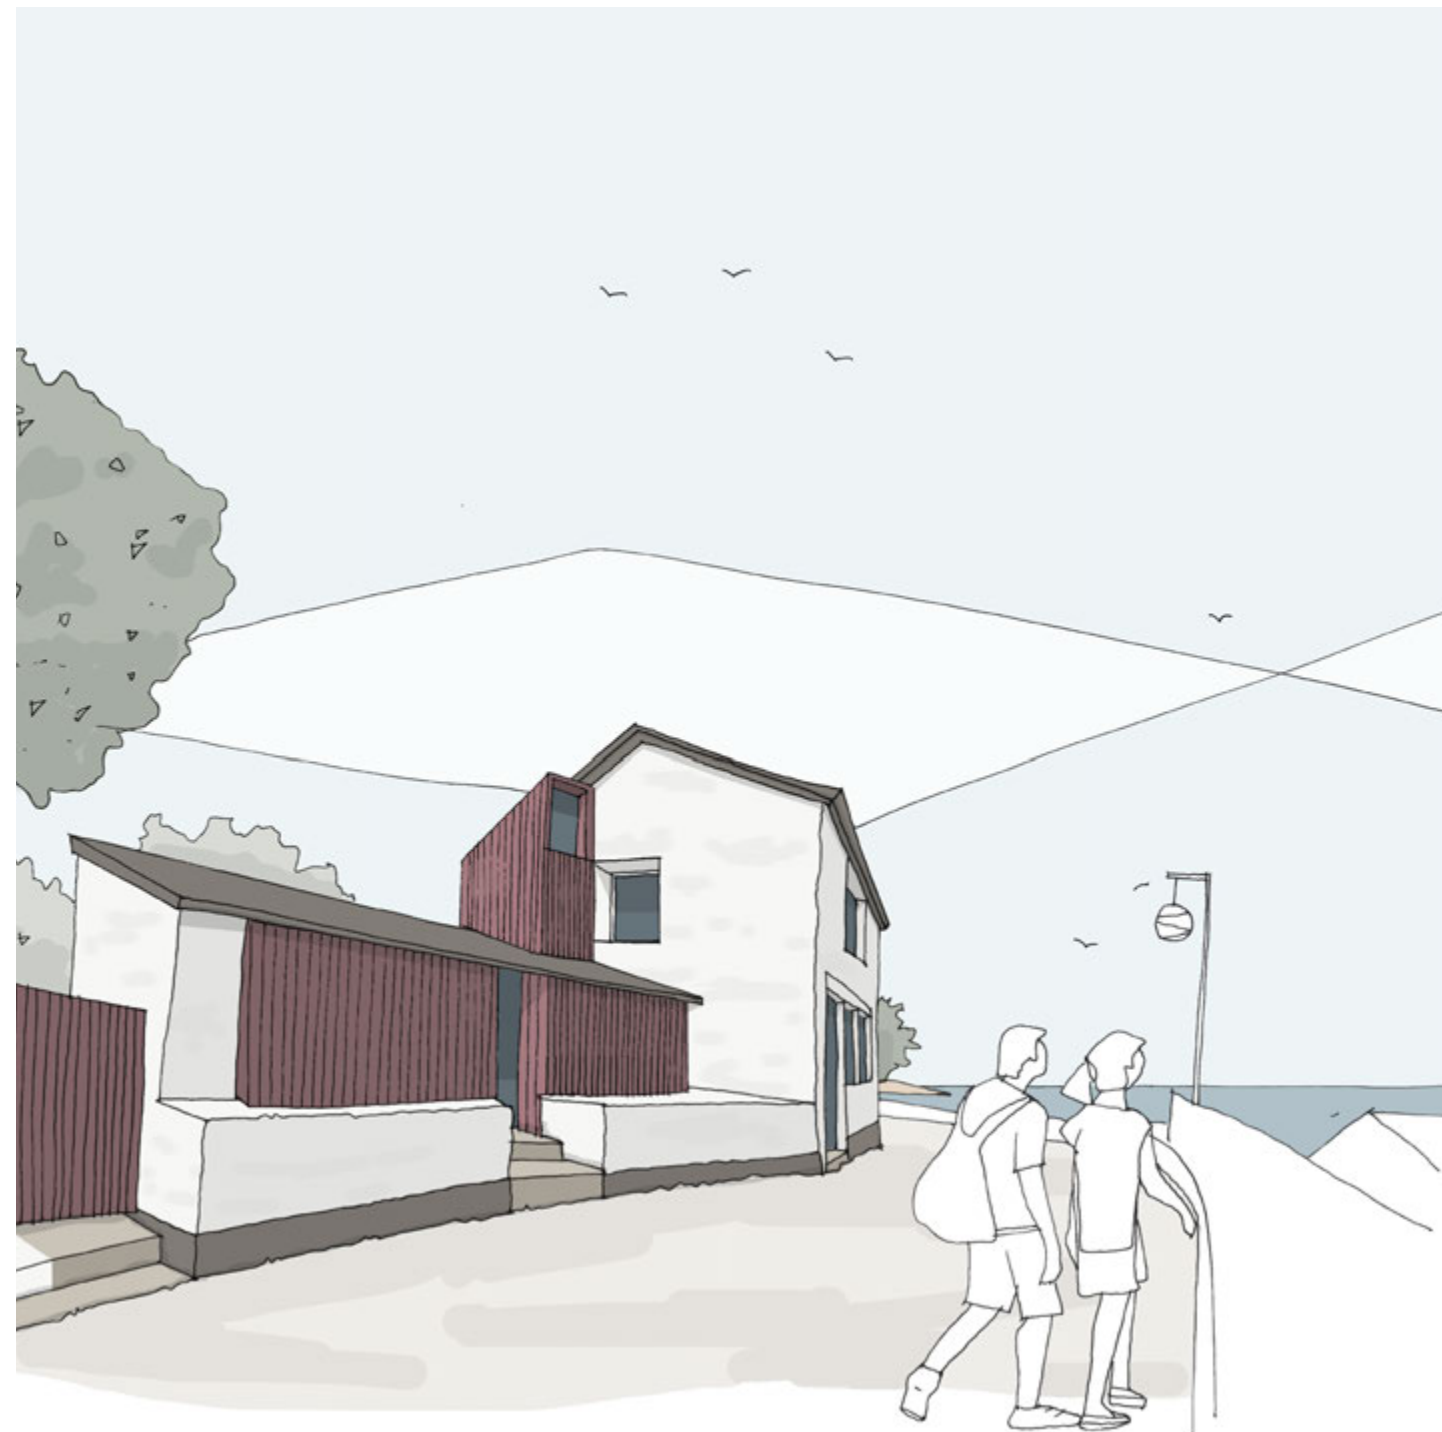
This option offers a significant functional improvement and greater usability and flexibility, but it requires careful design to avoid negative impact on the heritage significance, particularly given the value of the shelters and the sensitivity of the setting. It is also the most demanding option in terms of cost, land and deliverability.

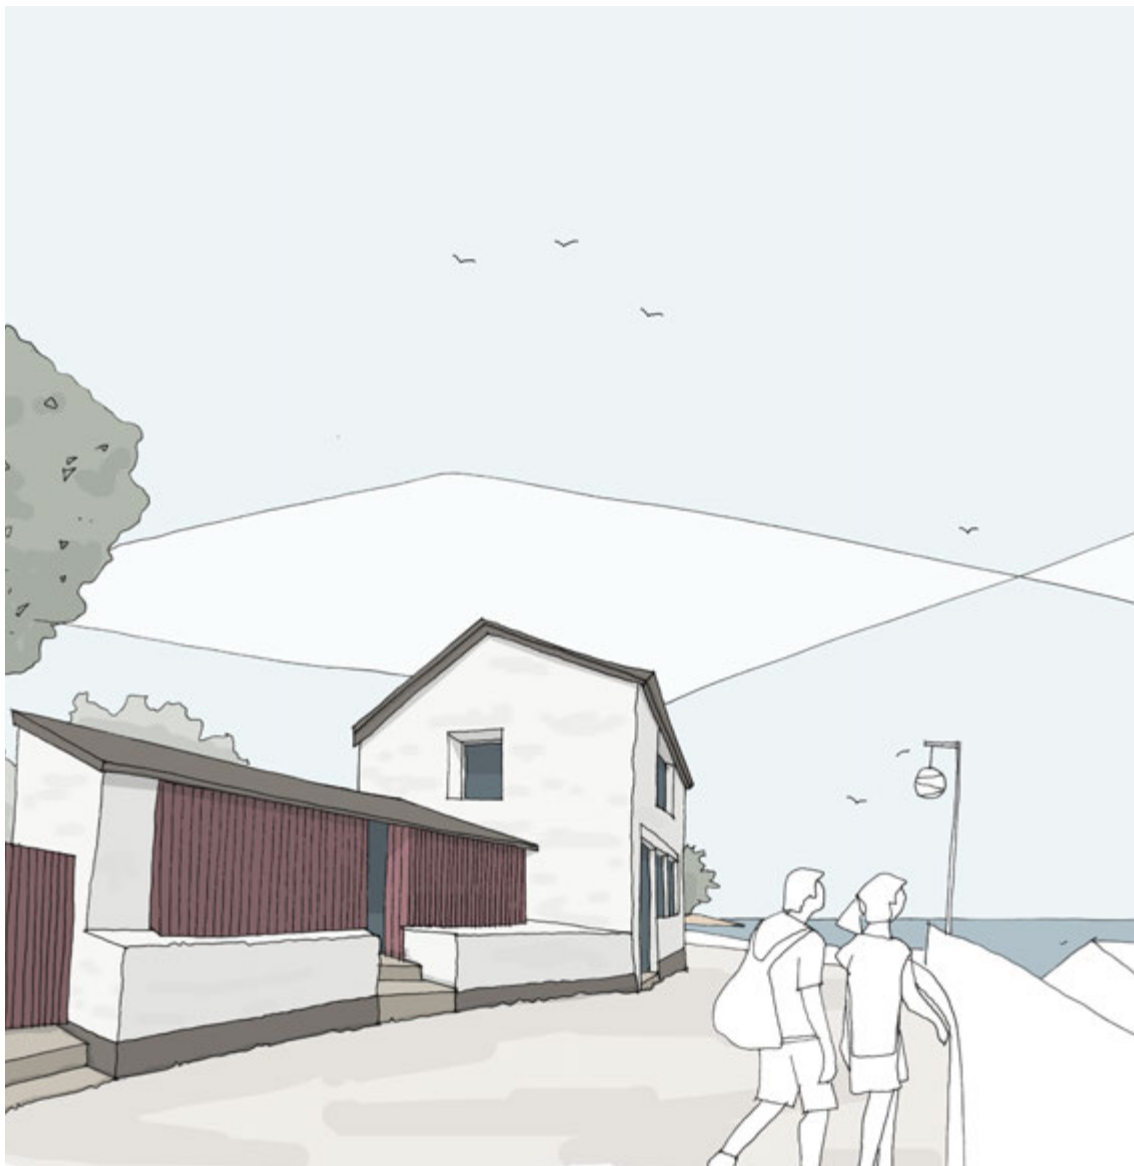
This version would feature the partial enclosure of the south shelter, and the upgrade and enclosing of the ground floor area of the out-house. The roof would be a continuous plane across the existing south shelter and the out-house.

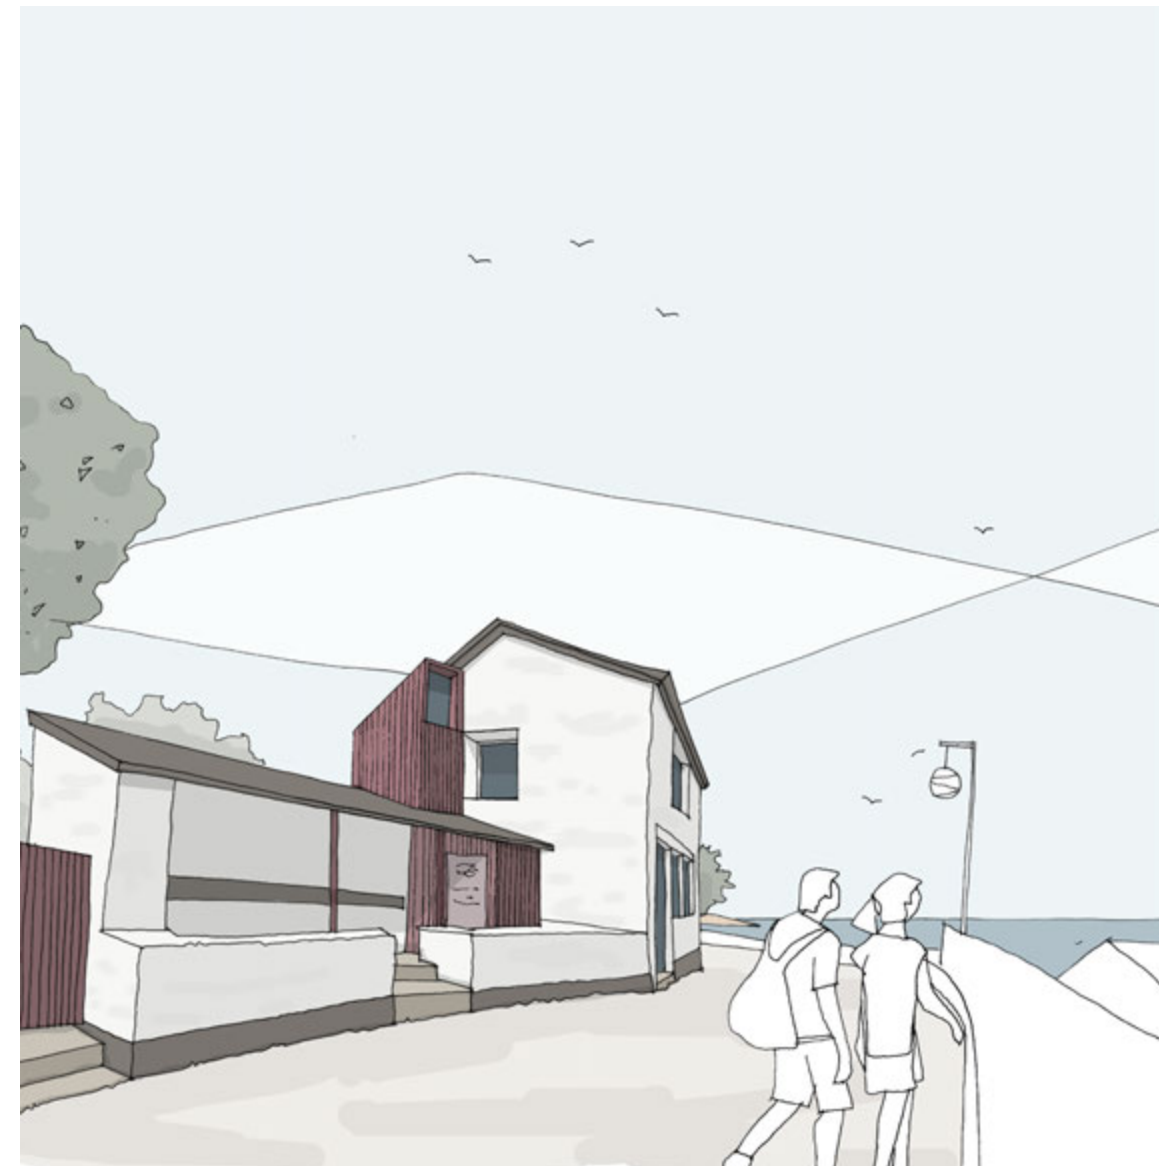
#### OPTION 3B

This version would feature the upgrade and enclosing of the ground floor area of the out-house, and the modestly scaled 'pop up' at first floor to create the WC / washing facilities for the first floor space. The exhibition / information in the south wing would be modest in terms of the intervention.
